Pre-Purchase Standard Property & Timber Pest Report

in accordance with AS 4349.1 & 4349.3

Report number:	5900000
Inspection Date:	05th Apr, 2022
Property Address	1 Sample Street, Sample Report 0000 Australia

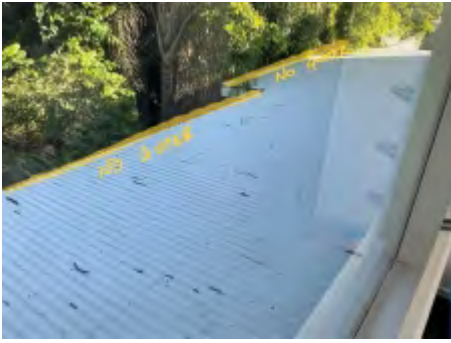
Rear patio

Was evidence of the original construction and any alterations or additions to the building not complete in the work synonymous with construction noted (but does not include building services)?	Yes, the following evidence was found
Incomplete construction evidence:	Rear covered roof area is incomplete. No facial, gutters, down pipes or soffit sheeting installed.

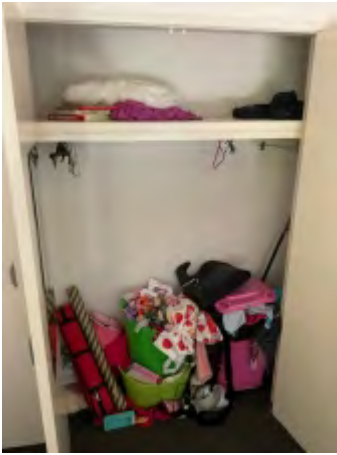
Obstructions

Were there any obstructions that may conceal possible defects?	The following obstructions may conceal defects:
--	---

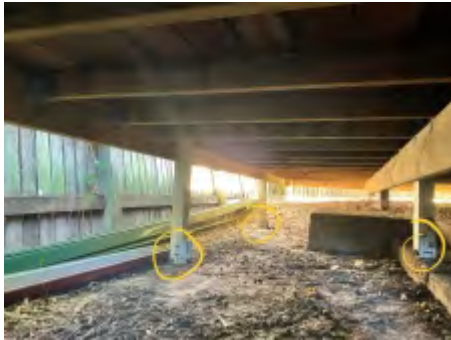
Rear patio footings

Footings to rear deck area appear to be inadequate. The rear deck and roof structure appears to be supported off the existing handstand area under. Recommend that a structural engineer inspect and provide advice.

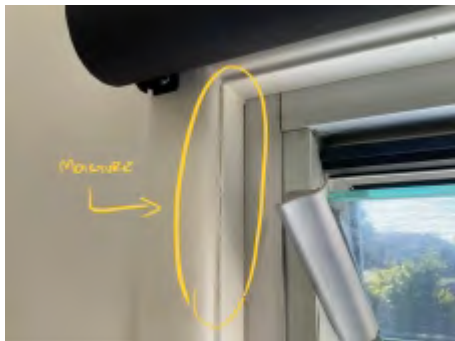
Many of the windows appear to be letting water. Signs of cracking and moisture damage to architraves generally throughout.

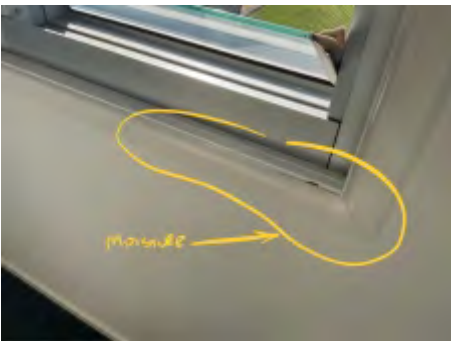
Many of the windows appear to be letting water. Signs of cracking and moisture damage to architraves generally throughout.

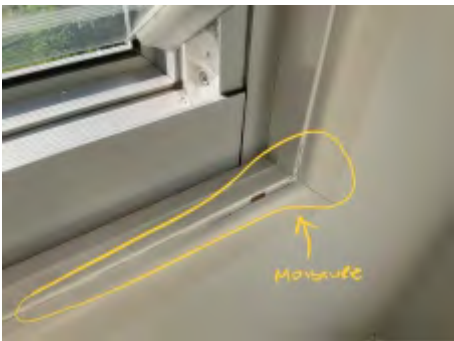
Many of the windows appear to be letting water. Signs of cracking and moisture damage to architraves generally throughout.

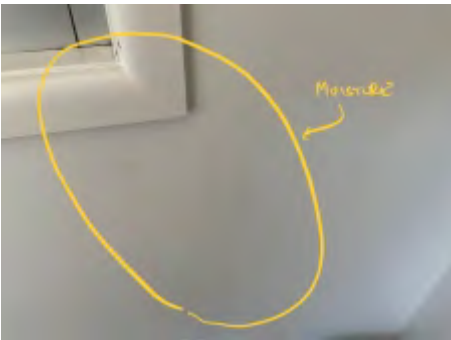
Many of the windows appear to be letting water. Signs of cracking and moisture damage to architraves generally throughout.

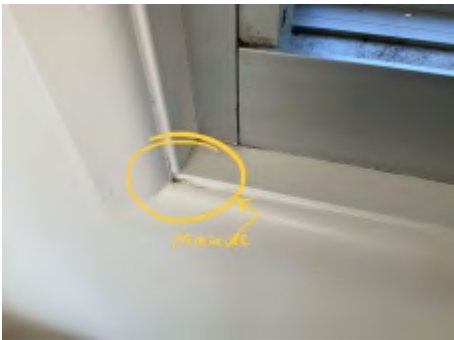
Many of the windows appear to be letting water. Signs of cracking and moisture damage to architraves generally throughout.

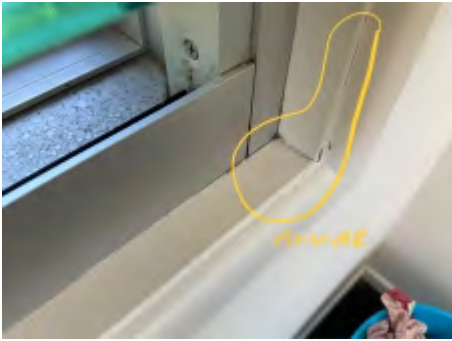
Many of the windows appear to be letting water. Signs of cracking and moisture damage to architraves generally throughout.

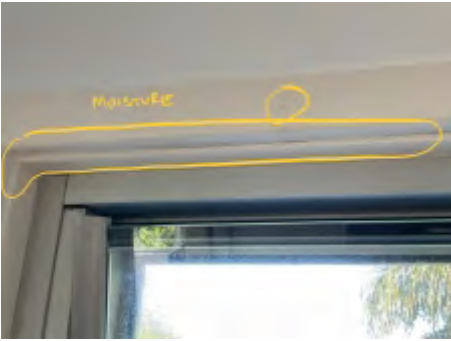
Many of the windows appear to be letting water. Signs of cracking and moisture damage to architraves generally throughout.

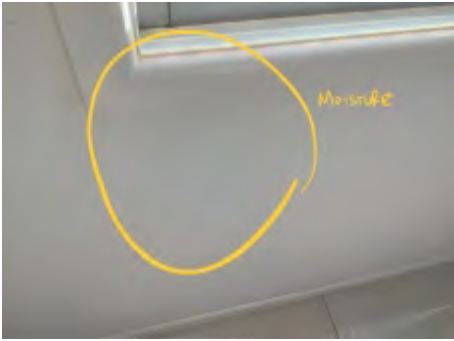
Many of the windows appear to be letting water. Signs of cracking and moisture damage to architraves generally throughout.

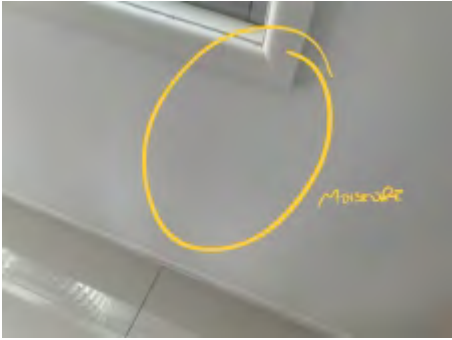
Many of the windows appear to be letting water. Signs of cracking and moisture damage to architraves generally throughout.

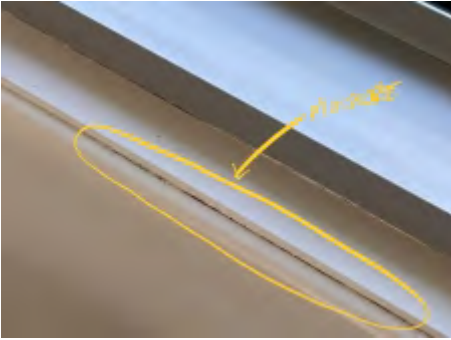
Many of the windows appear to be letting water. Signs of cracking and moisture damage to architraves generally throughout.

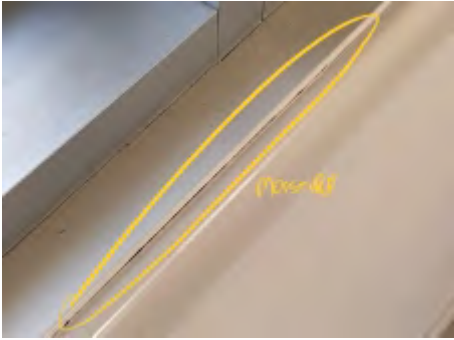
Many of the windows appear to be letting water. Signs of cracking and moisture damage to architraves generally throughout.

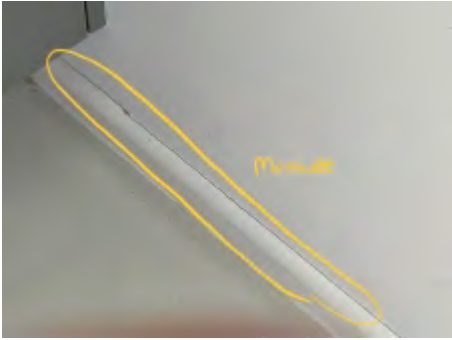
Many of the windows appear to be letting water. Signs of cracking and moisture damage to architraves generally throughout.

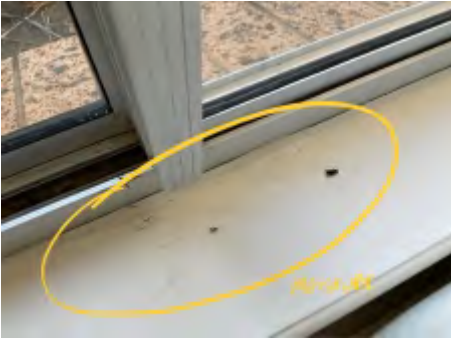
Many of the windows appear to be letting water. Signs of cracking and moisture damage to architraves generally throughout.

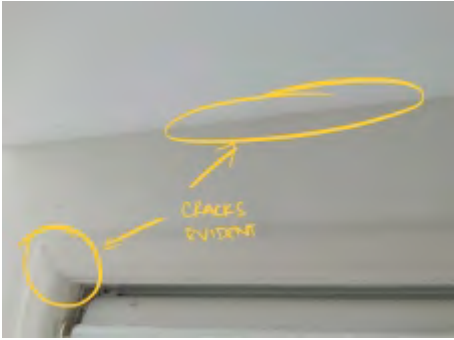
Many of the windows appear to be letting water. Signs of cracking and moisture damage to architraves generally throughout.

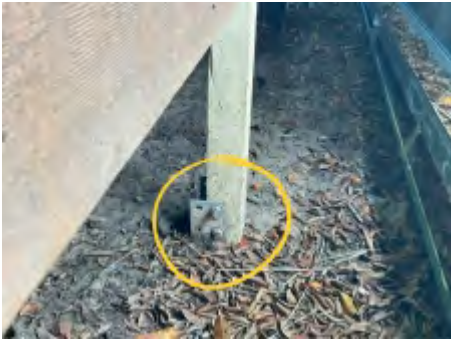
Footings to rear deck area appear to be inadequate. The rear deck and roof structure appears to be supported off the existing handstand area under. Additionally some of the fixings are installed poorly and supporting posts partly sitting on supporting stirrups. Recommend that a structural engineer inspect and provide advice.

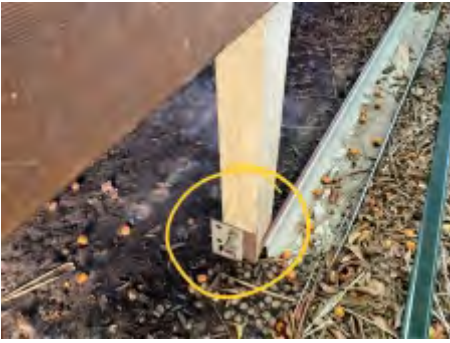
Footings to rear deck area appear to be inadequate. The rear deck and roof structure appears to be supported off the existing handstand area under. Additionally some of the fixings are installed poorly and supporting posts partly sitting on supporting stirrups. Recommend that a structural engineer inspect and provide advice.

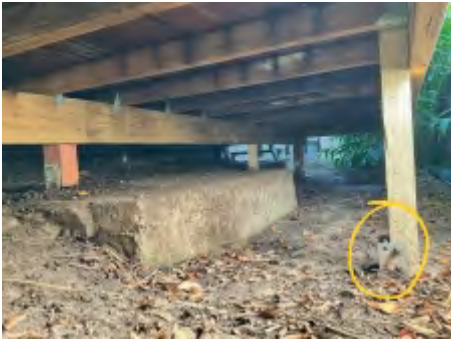
Footings to rear deck area appear to be inadequate. The rear deck and roof structure appears to be supported off the existing handstand area under. Additionally some of the fixings are installed poorly and supporting posts partly sitting on supporting stirrups. Recommend that a structural engineer inspect and provide advice.

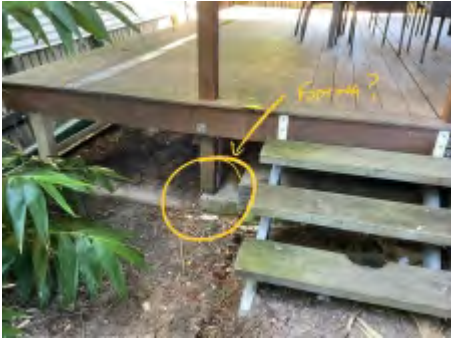
Footings to rear deck area appear to be inadequate. The rear deck and roof structure appears to be supported off the existing handstand area under. Additionally some of the fixings are installed poorly and supporting posts partly sitting on supporting stirrups. Recommend that a structural engineer inspect and provide advice.

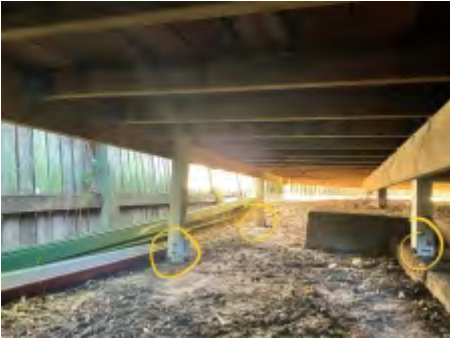
Footings to rear deck area appear to be inadequate. The rear deck and roof structure appears to be supported off the existing handstand area under. Additionally some of the fixings are installed poorly and supporting posts partly sitting on supporting stirrups. Recommend that a structural engineer inspect and provide advice.

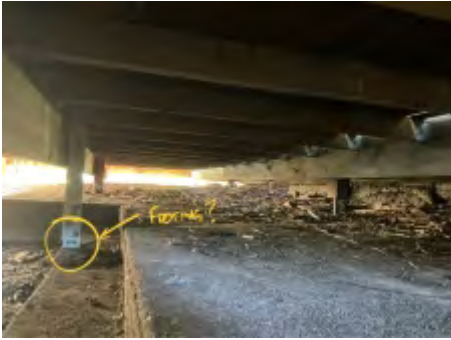
Footings to rear deck area appear to be inadequate. The rear deck and roof structure appears to be supported off the existing handstand area under. Additionally some of the fixings are installed poorly and supporting posts partly sitting on supporting stirrups. Recommend that a structural engineer inspect and provide advice.

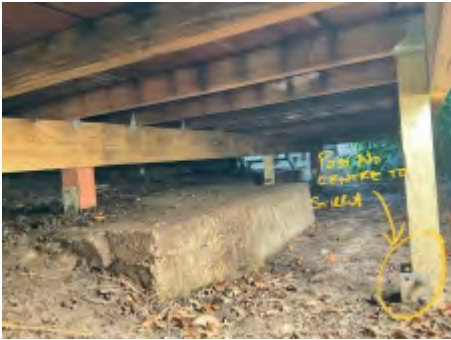
Footings to rear deck area appear to be inadequate. The rear deck and roof structure appears to be supported off the existing handstand area under. Additionally some of the fixings are installed poorly and supporting posts partly sitting on supporting stirrups. Recommend that a structural engineer inspect and provide advice.

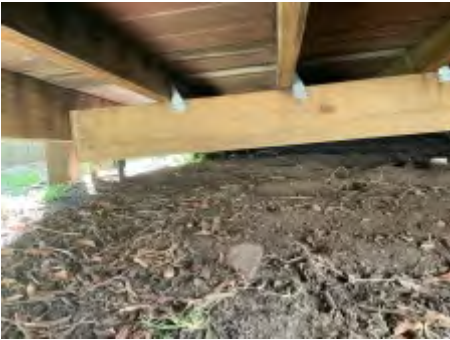
Footings to rear deck area appear to be inadequate. The rear deck and roof structure appears to be supported off the existing handstand area under. Additionally some of the fixings are installed poorly and supporting posts partly sitting on supporting stirrups. Recommend that a structural engineer inspect and provide advice.

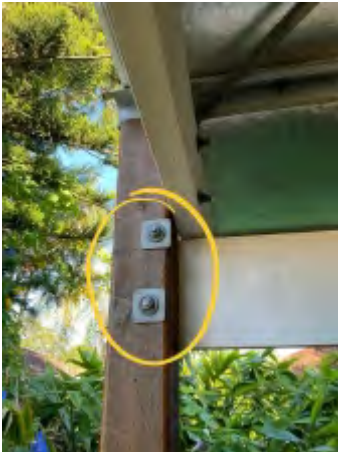
Footings to rear deck area appear to be inadequate. The rear deck and roof structure appears to be supported off the existing handstand area under. Additionally some of the fixings are installed poorly and supporting posts partly sitting on supporting stirrups. Recommend that a structural engineer inspect and provide advice.

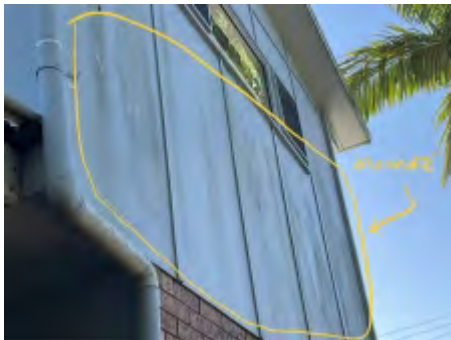
External light grey cladding appears to be affected by consistent moisture issues. This can lead to mould issues internally. Recommend a building contractor inspect and provide advice.

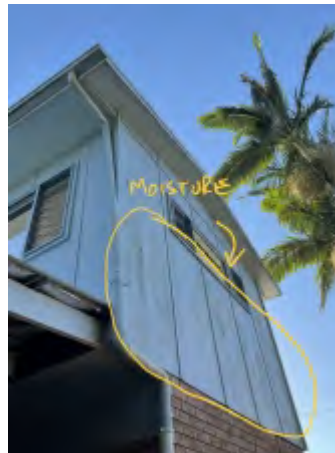
External light grey cladding appears to be affected by consistent moisture issues. This can lead to mould issues internally. Recommend a building contractor inspect and provide advice.

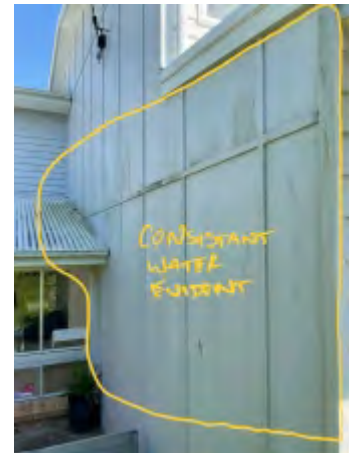
External light grey cladding appears to be affected by consistent moisture issues. This can lead to mould issues internally. Recommend a building contractor inspect and provide advice.

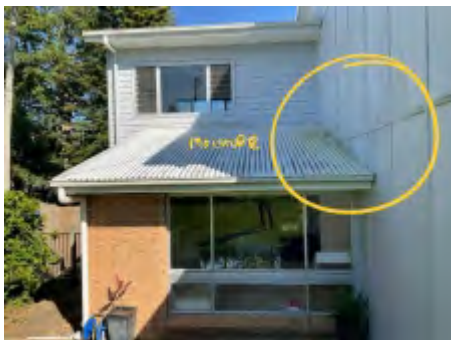
External light grey cladding appears to be affected by consistent moisture issues. This can lead to mould issues internally. Recommend a building contractor inspect and provide advice.

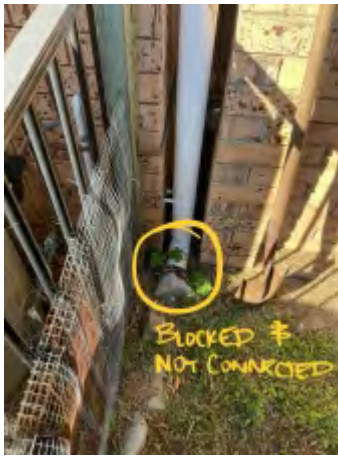
There is no in-ground drainage reticulation to take roof water away from the property.

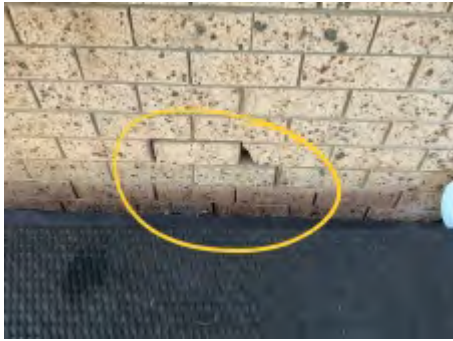
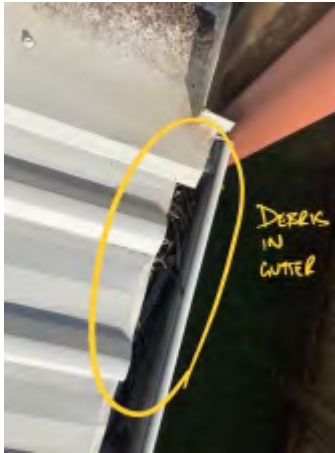
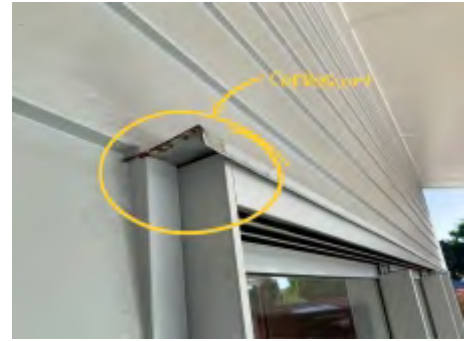
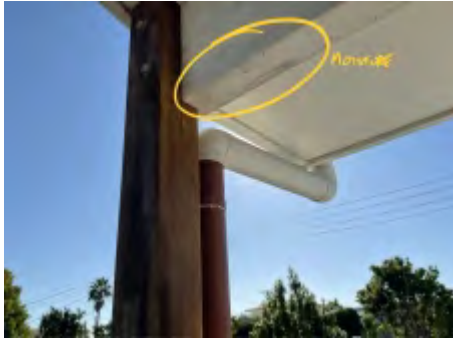
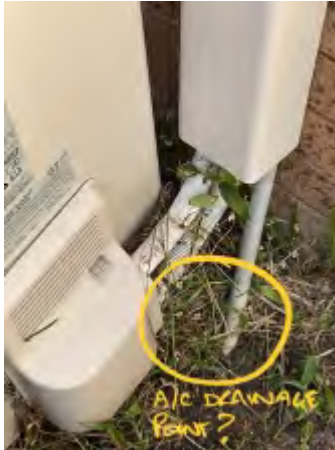
D22 Minor defects: Monitoring and normal maintenance must be carried out (see also Section F 'Important note'). How many minor defects were noted?	a few
Comments on Minor Defects	Wall and ceiling linings - scuffs, dents, scratches and blemishes generally throughout, Eaves - gaps evident to eave and wall junctions, Eaves - water damage evident, Gutters - appear to be holding water, Downpipes - not watertight at connections, Downpipes - not fixed to wall securely, External hard pavements - hairline cracks evident, Roof - corrosion evident, Drainage - surface water drainage points appear inadequate, Ceiling linings - hairline cracks evident to cornice and wall joints, Wall linings - hairline cracks evident at window heads, Skirting and architraves - hairline cracks evident, Window reveals - hairline cracks evident

External Minor Defects

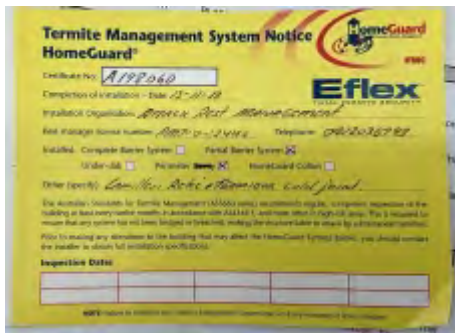
Termite Management System installed 13/11/13

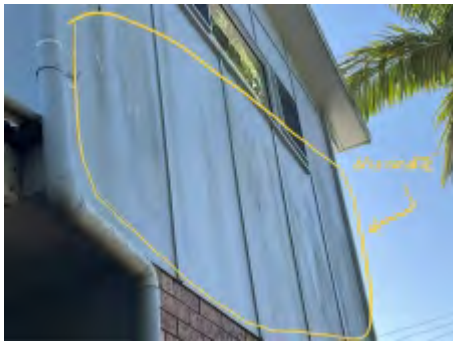
Signs of fungal decay.

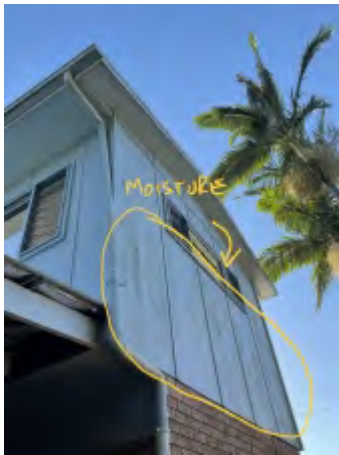
Signs of fungal decay.

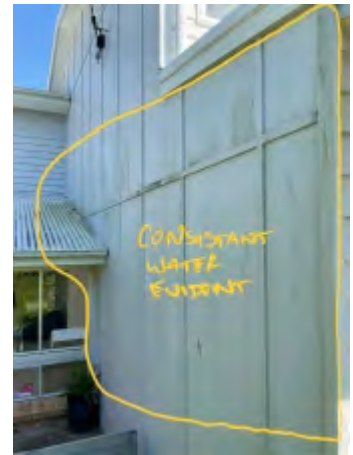
Signs of fungal decay.

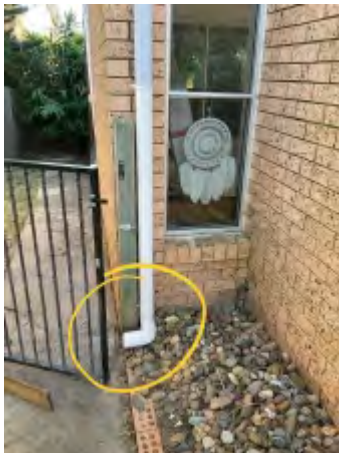
No Down Pipe Ground Connections

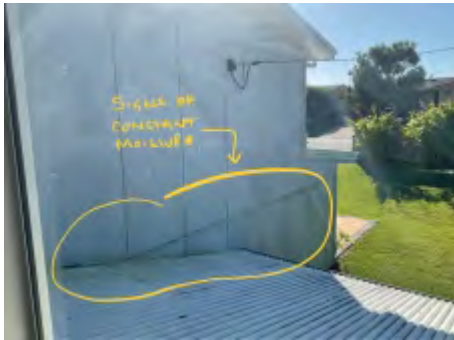
E9 Lack of adequate subfloor ventilation	Presence was undetermined
E10 The presence of excessive moisture	The following evidence was found
Location	Ground
Additional Comments	Ground has moisture present due to no drainage system to take roof water Ground has moisture present due to poor site drainage Facades have moss/mould present due to persistent dampness

Facades Moisture Affected

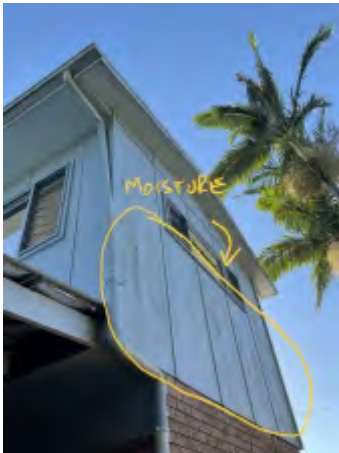
Facades Moisture Affected

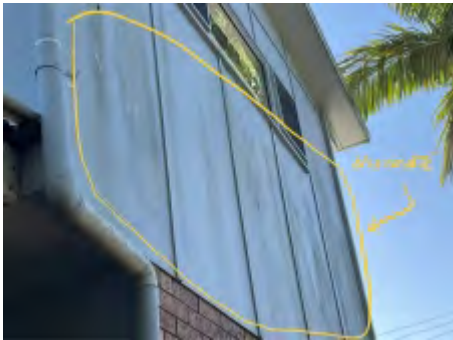
Facades Moisture Affected

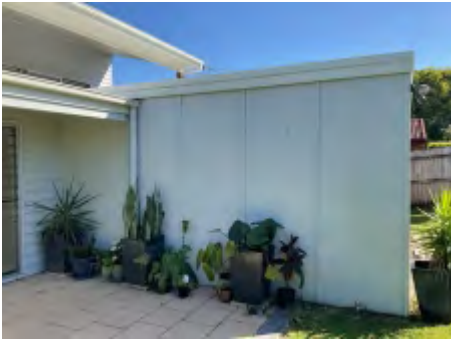
E11 Bridging or breaching of termite barriers and inspection zones	The following evidence was found
Location	External
Additional Comments	Various termite bridging locations including rear deck in contact with natural ground, area under staircase and entry walkway area.

Bridging

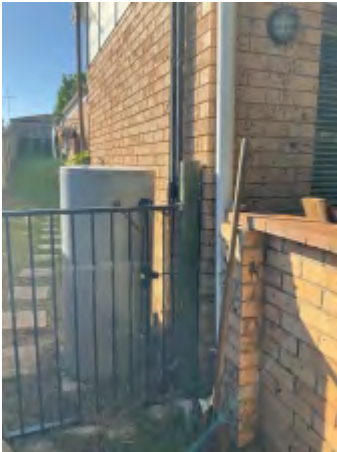
Bridging

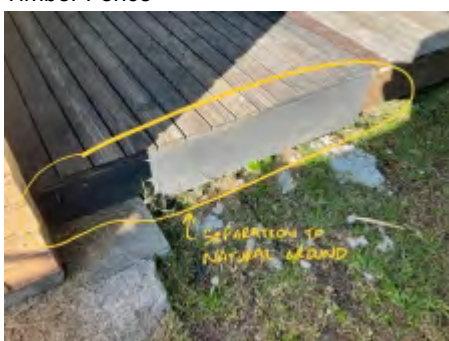
E12 Untreated or non-durable timber used in a hazardous environment	The following evidence was found
Location	External

Timber Deck
