Pre-Purchase Standard Property & Timber Pest Report

in accordance with AS 4349.1 & 4349.3

Report number:	5900000
Inspection Date:	05th Apr, 2022
Property Address	1 Sample Street, Sample Report 0000 Australia

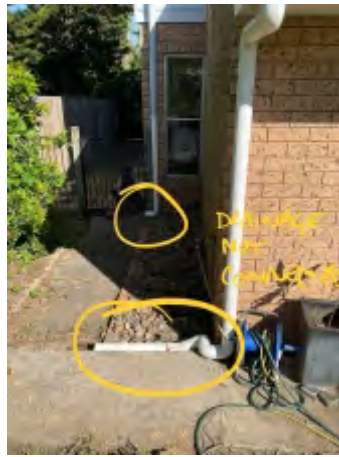
There is no in-ground drainage reticulation to take roof water away from the property.

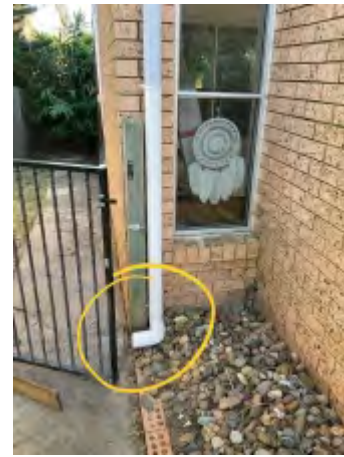
There is no in-ground drainage reticulation to take roof water away from the property.

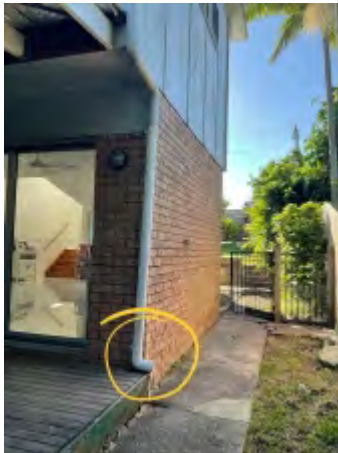
There is no in-ground drainage reticulation to take roof water away from the property.

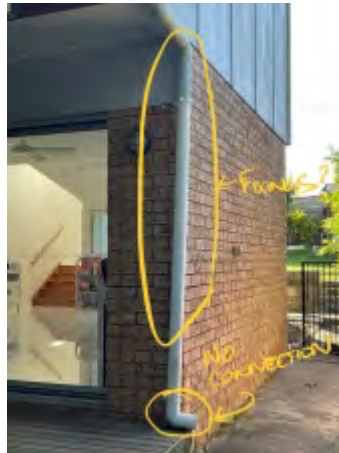
There is no in-ground drainage reticulation to take roof water away from the property.

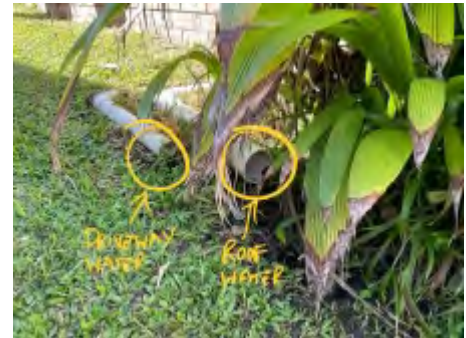
There is no in-ground drainage reticulation to take roof water away from the property.

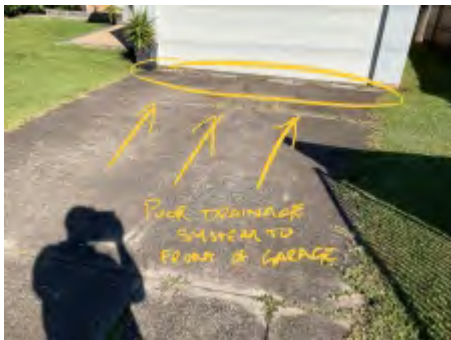
The drain to the front of the garage appears to be undersized to cope with surface water. Additionally there is no connection to an in ground drainage reticulation system to take water out to the street.

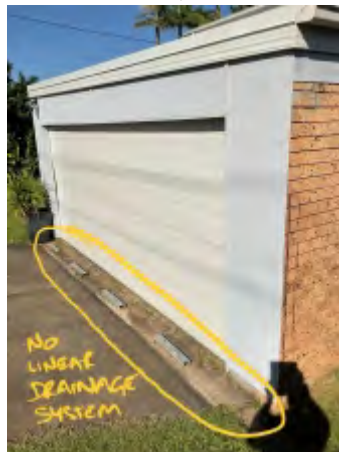
The drain to the front of the garage appears to be undersized to cope with surface water. Additionally there is no connection to an in ground drainage reticulation system to take water out to the street.

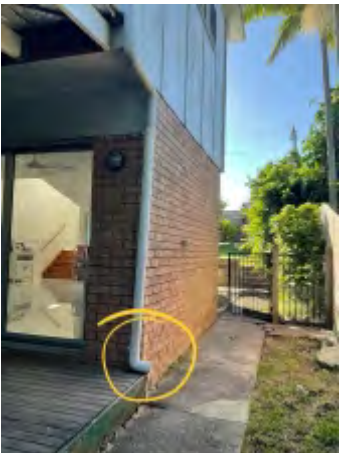
E9 Lack of adequate subfloor ventilation	Presence was undetermined
E10 The presence of excessive moisture	The following evidence was found
Location	Ground
Additional Comments	Ground has moisture present due to no drainage system to take roof water Ground has moisture present due to poor site drainage Facades have moss/mould present due to persistent dampness

No Down Pipe Ground Connections

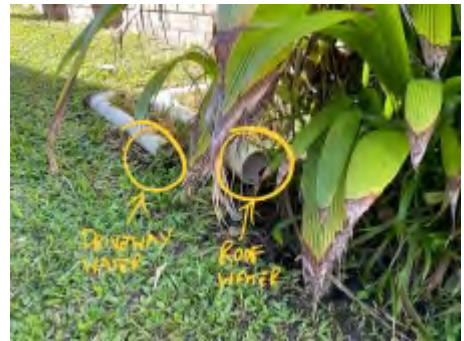
No Down Pipe Ground Connections

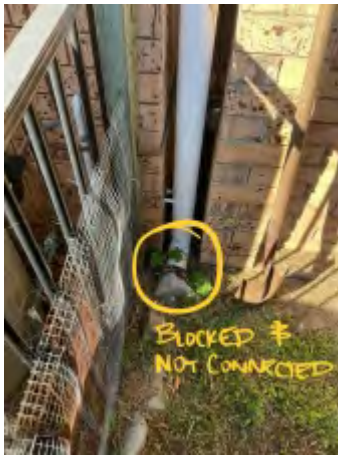
No Down Pipe Ground Connections

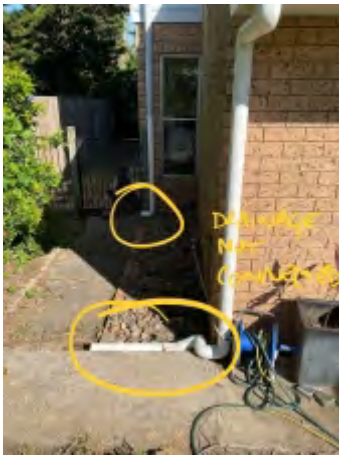
No Down Pipe Ground Connections

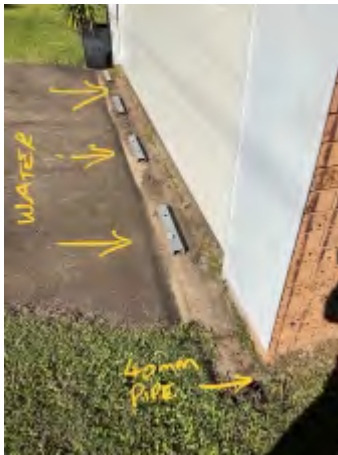
No Site Drainage

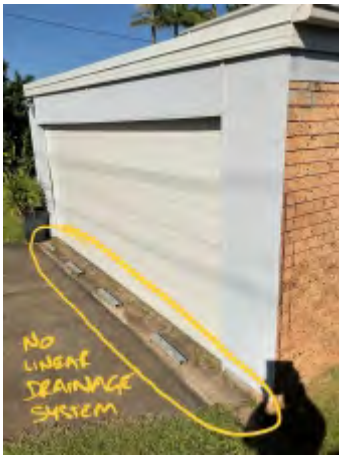
No Site Drainage

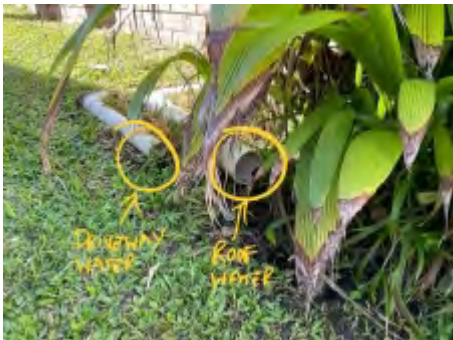
No Site Drainage

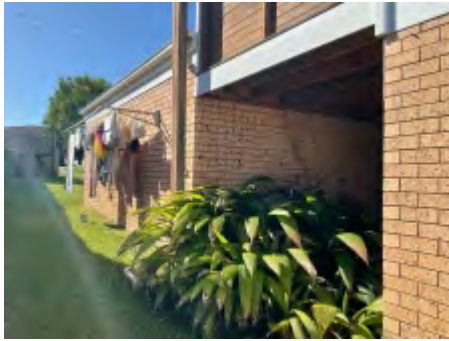
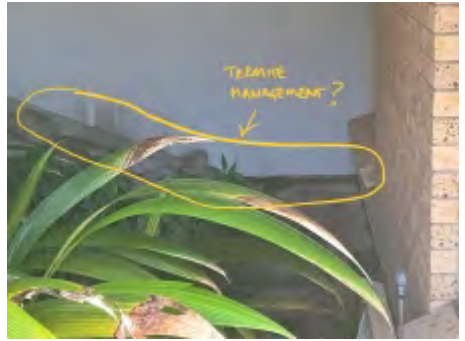
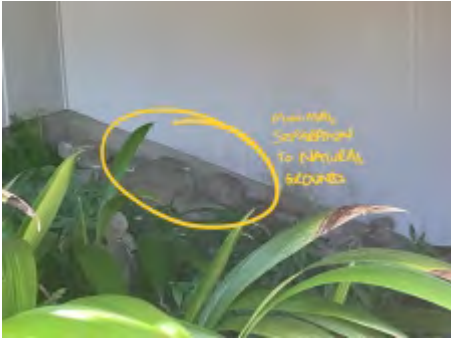
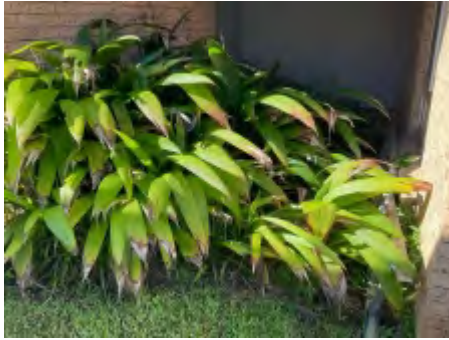
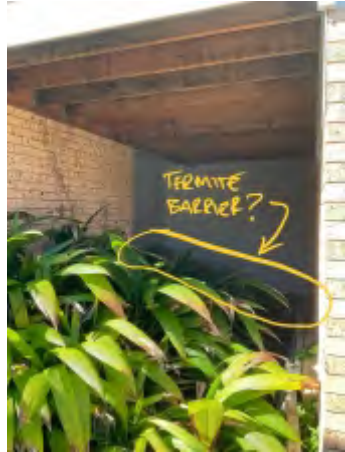
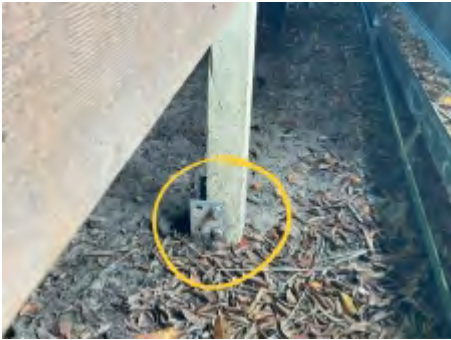
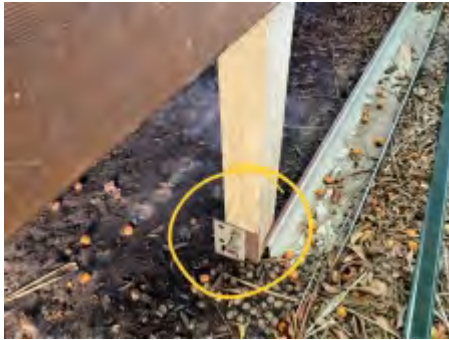
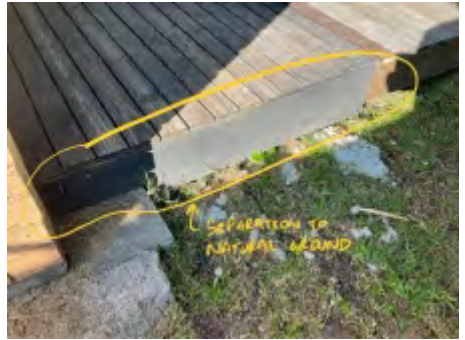
E11 Bridging or breaching of termite barriers and inspection zones	The following evidence was found
Location	External
Additional Comments	Various termite bridging locations including rear deck in contact with natural ground, area under staircase and entry walkway area.

Bridging

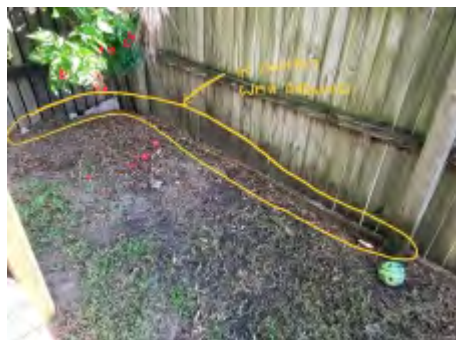
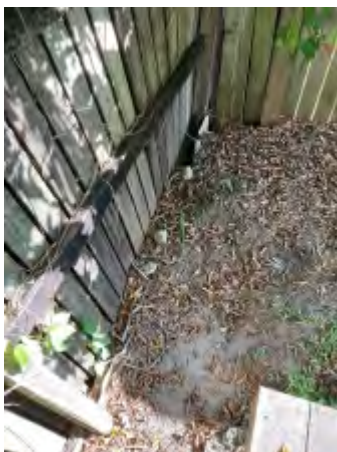
Additional Comments	Rear timber fence in contact with ground Rear deck in contact with natural ground
---------------------	--

Timber Fence

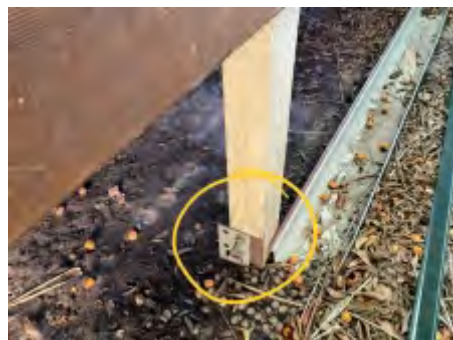
Timber Deck
